Confidential Inspection Report

LOCATED AT:
Idaho 83254

INSPECTED ON:
Saturday, December 9, 2017

Inspector, Derek Reed
Precision Home Inspection

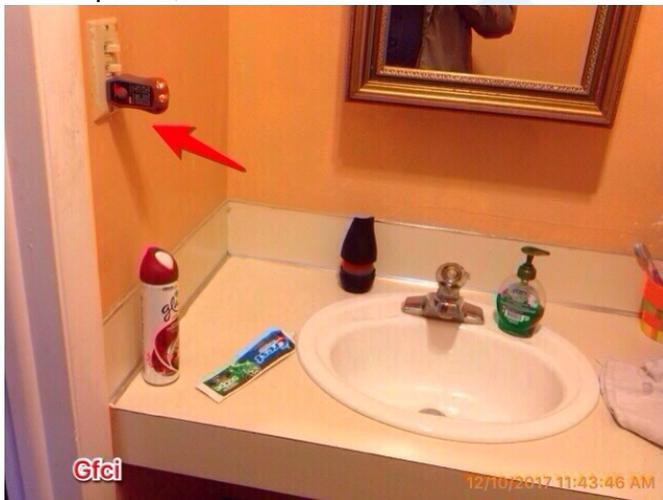
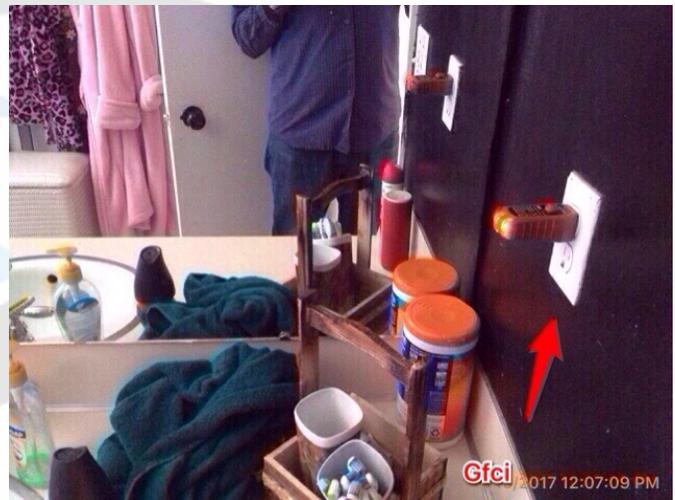
No GFCI protection is installed. We recommend upgrading by installing ground fault receptacles in all locations required by present standards. These include receptacles near sink basins, in bathrooms, garages, crawl spaces, and the exterior.

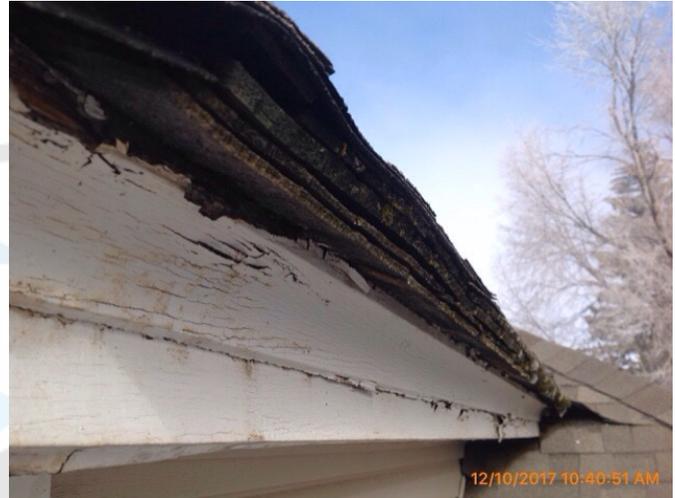
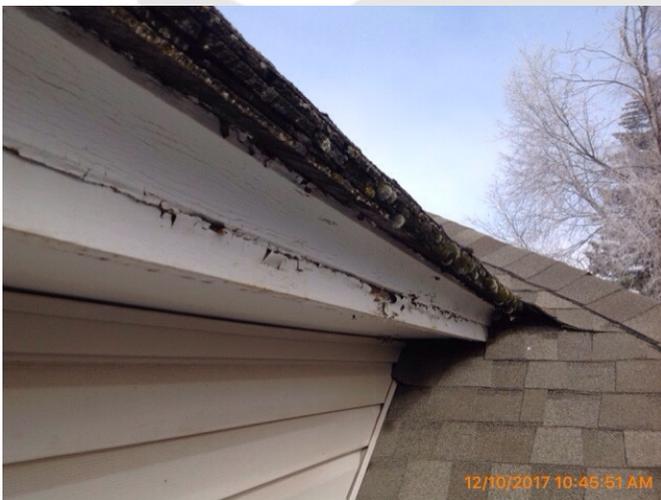
The moss on the ends of shakes tends to retain moisture and accelerate deterioration over a long period of time. However, the cost of cleaning and treating the shakes should be weighed against the potential gain of a few years in roof life.

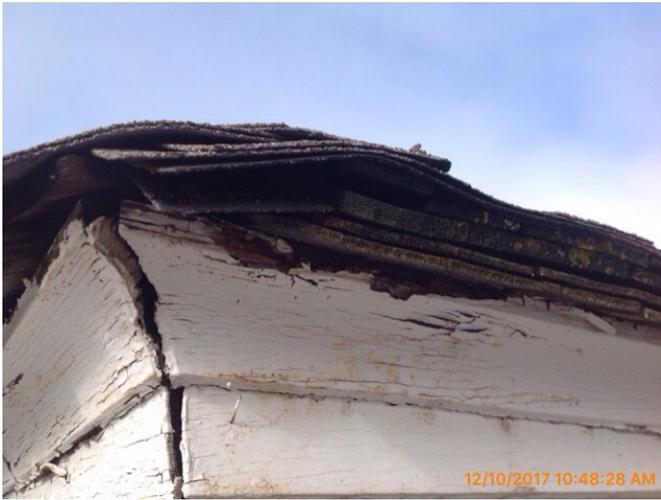
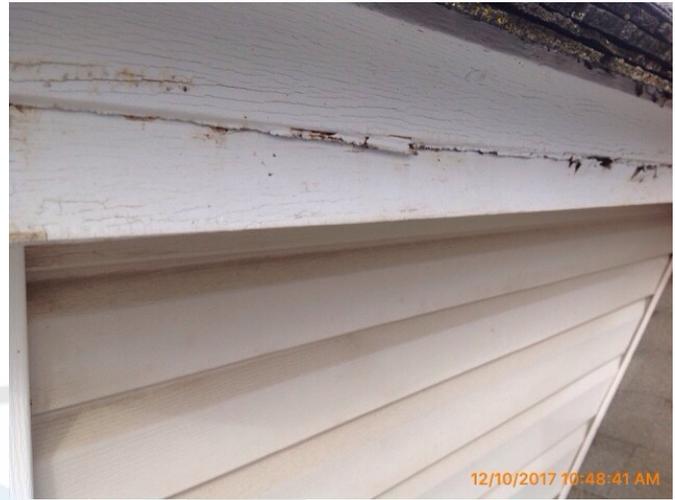
There are presently multiple layers of roofing materials applied over this structure. When the roof is replaced, at least the top layer will have to be removed. Requirements vary between jurisdictions as to the maximum number of layers permitted.

Removal of all the layers is usually the best procedure. Resheathing and reflashng will help reduce the weight on the framing, the possibility of cracking or other symptoms of overloading, as well as prolong the useful life of the new roof.

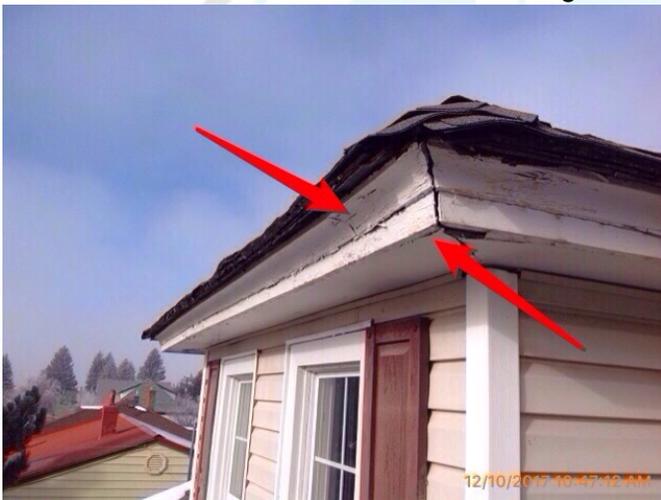
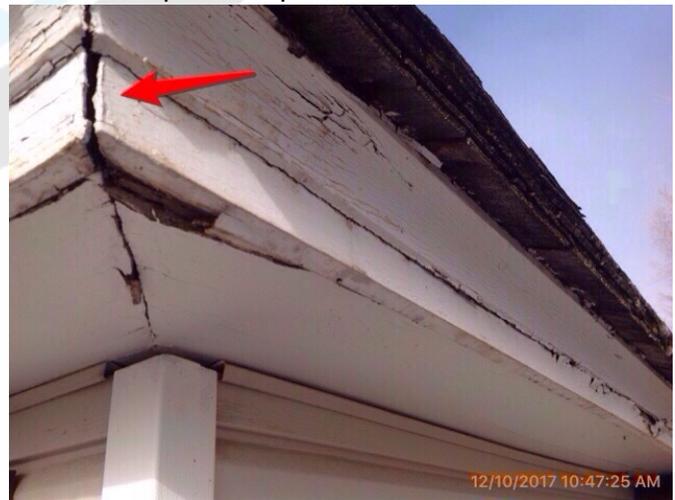
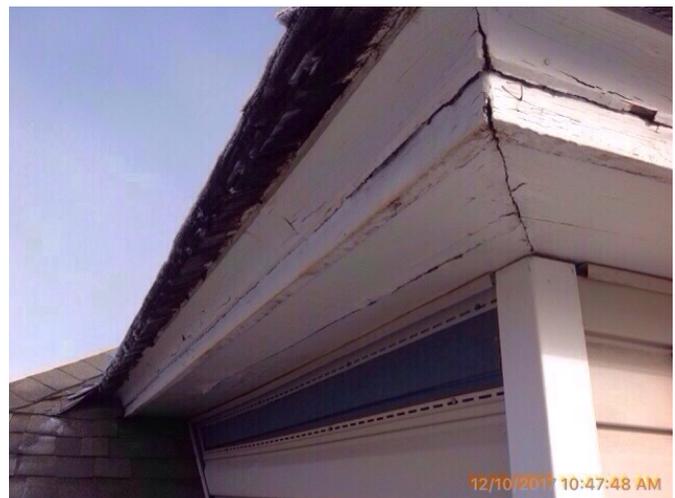
Sections of the eaves at the front are damaged. We recommend repair or replacement.
