Confidential Inspection Report

LOCATED AT:
Idaho 83254

INSPECTED ON:
Saturday, December 9, 2017

Inspector, Derek Reed
Precision Home Inspection

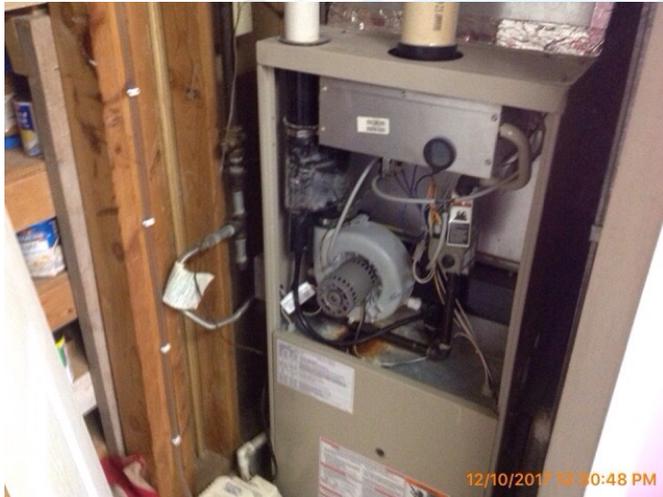
VENT

The heating system vent is properly installed and appears in serviceable condition where seen.

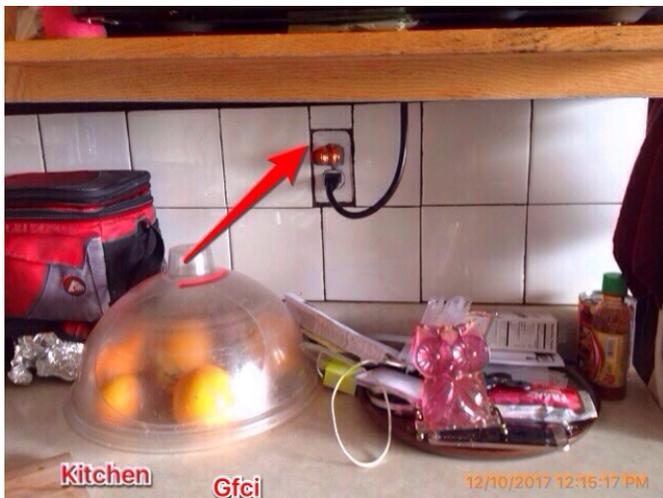
GENERAL COMMENT

The electrical system is in good condition and the components are properly installed. No unsafe conditions were observed in the readily accessible portions of the installation.

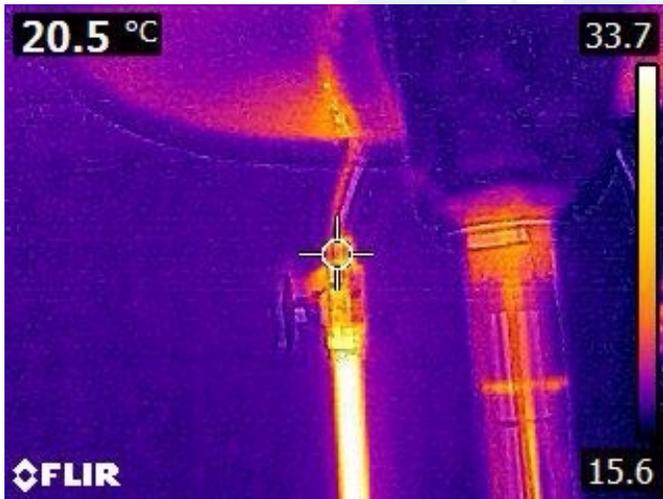
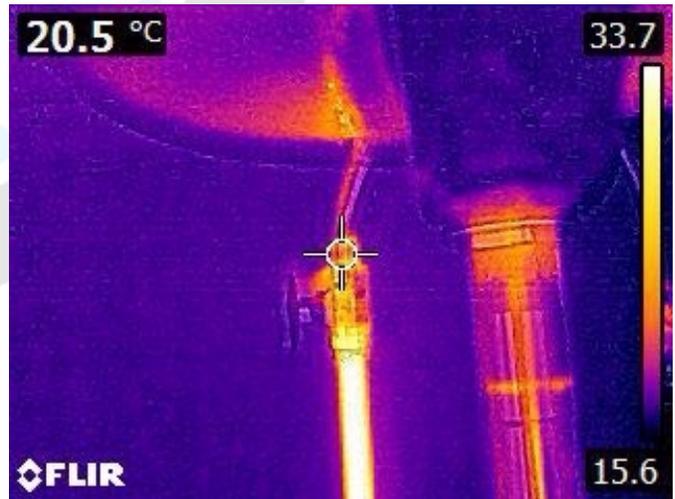
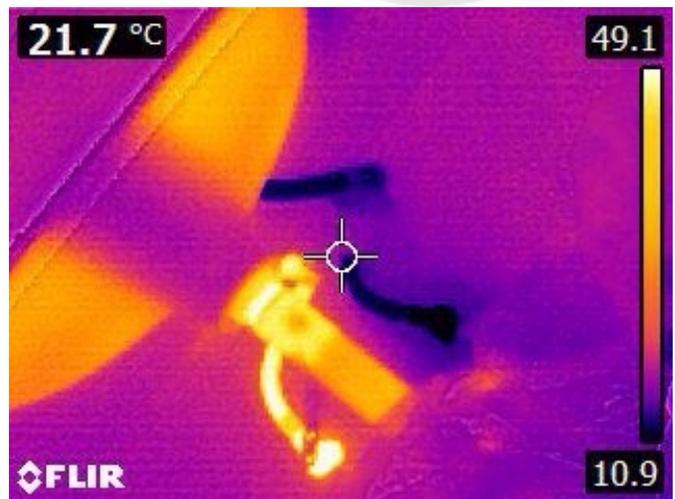
INTERIOR SUPPLY

The exposed and accessible supply piping generally appears to be properly installed and in good condition.

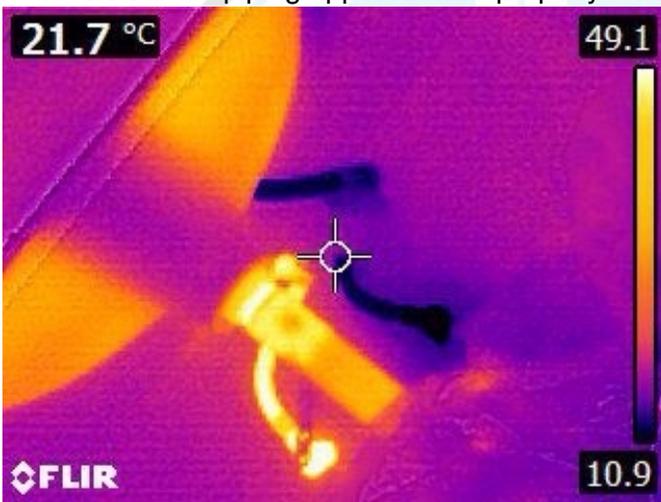
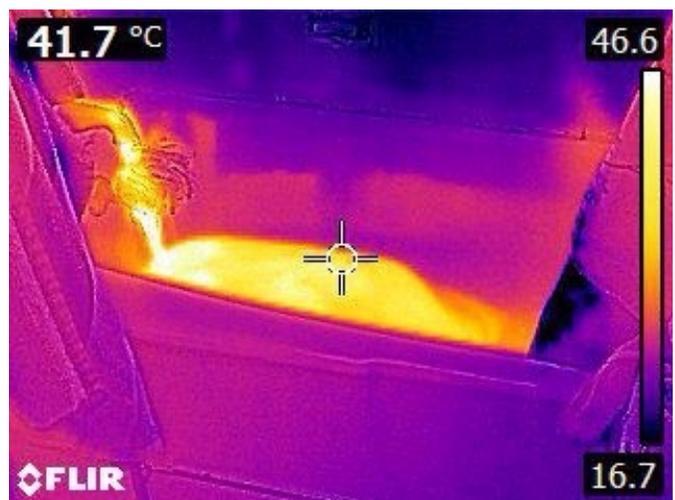
DRAIN LINES

The visible drain piping appears to be properly installed and in serviceable condition.

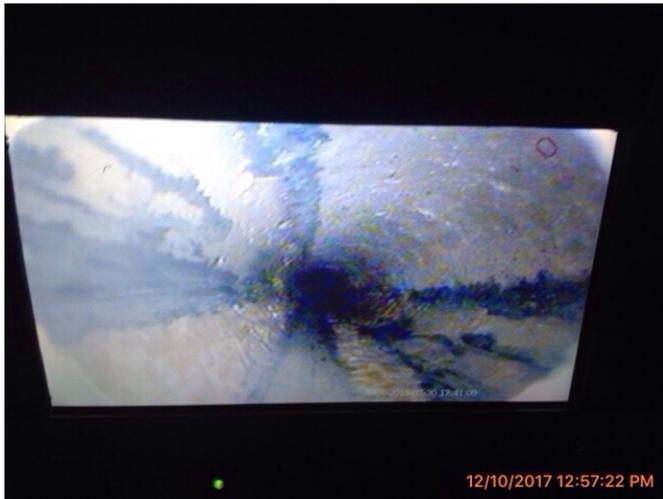
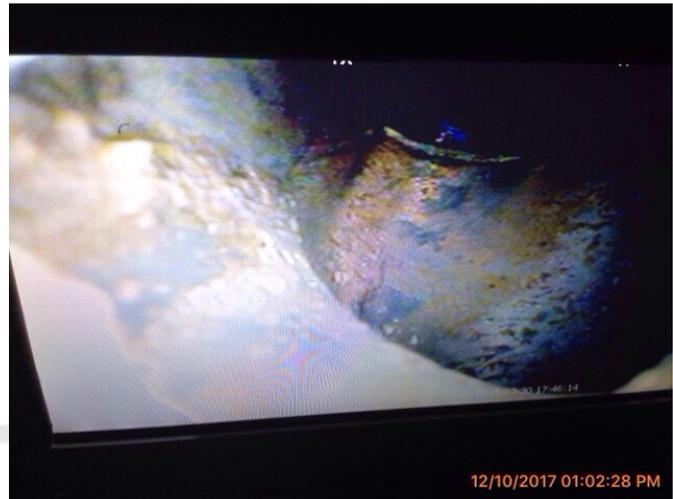
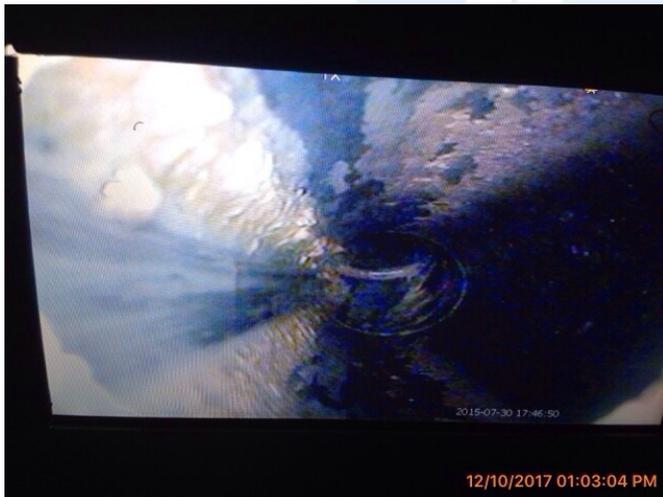
The visible drain piping appears to be generally properly installed and in serviceable condition. We a full camera review was conducted

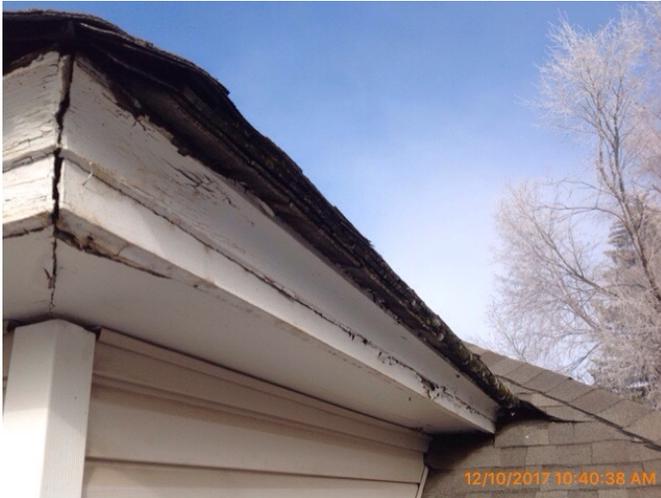
SURFACE (SHAKE)

The moss on the ends of shakes tends to retain moisture and accelerate deterioration over a long period of time. However, the cost of cleaning and treating the shakes should be weighed against the potential gain of a few years in roof life.

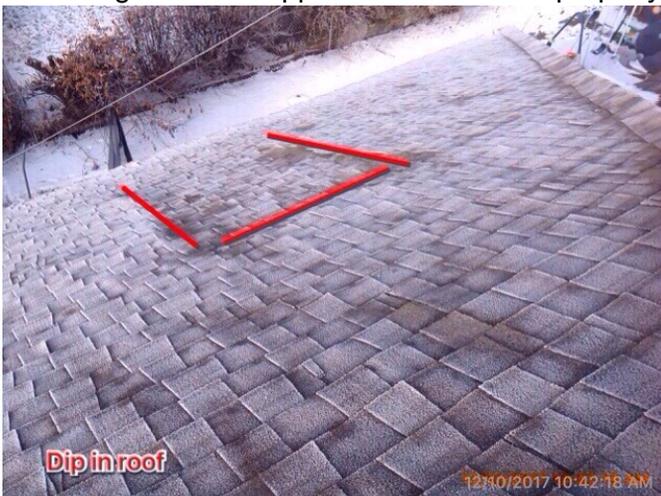
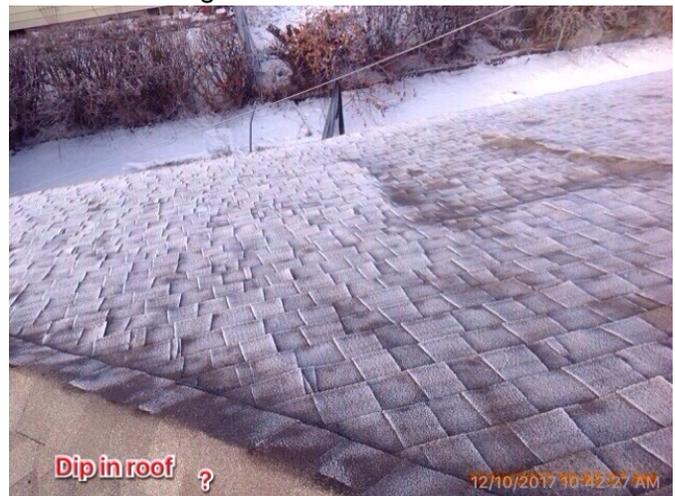
SURFACE

The shingle surface appears to have been properly installed and is in good condition.

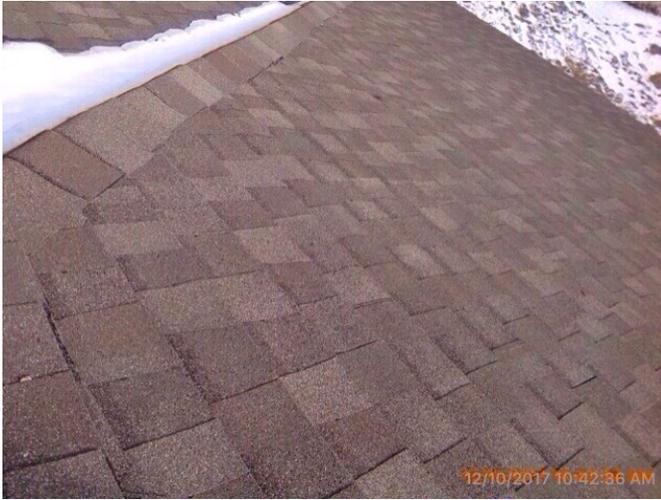
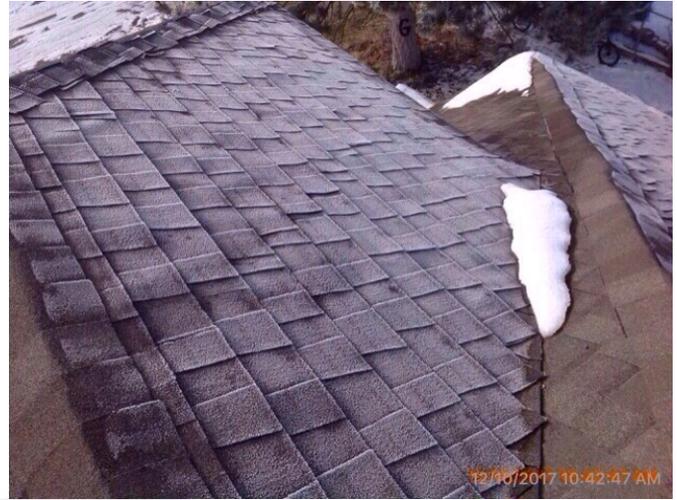
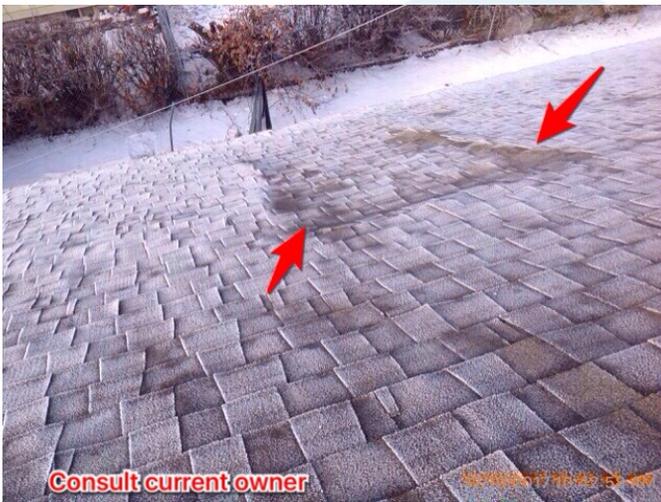
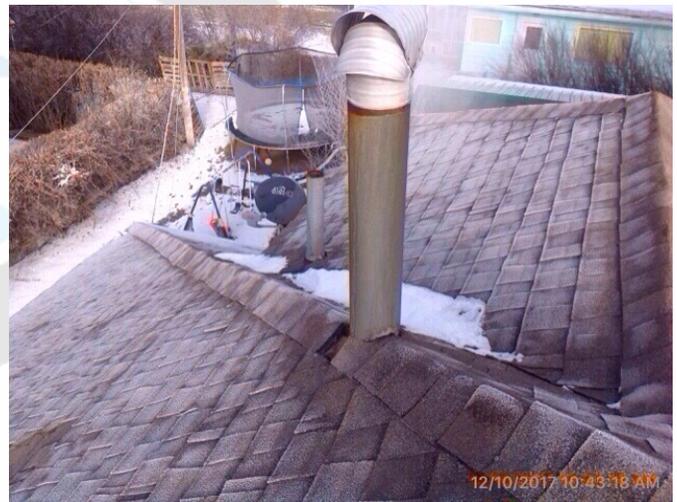
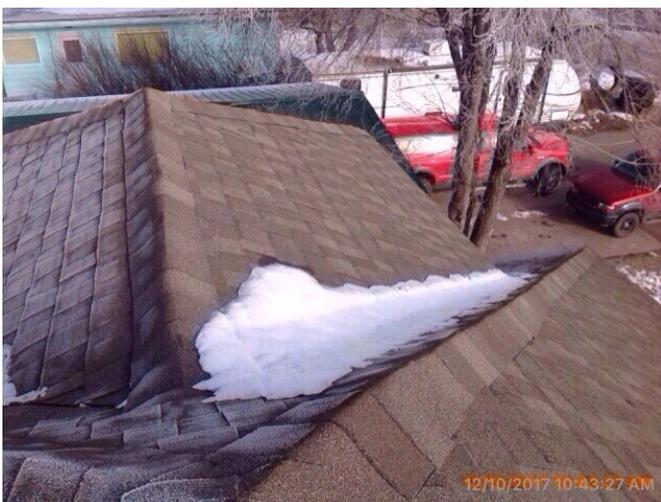
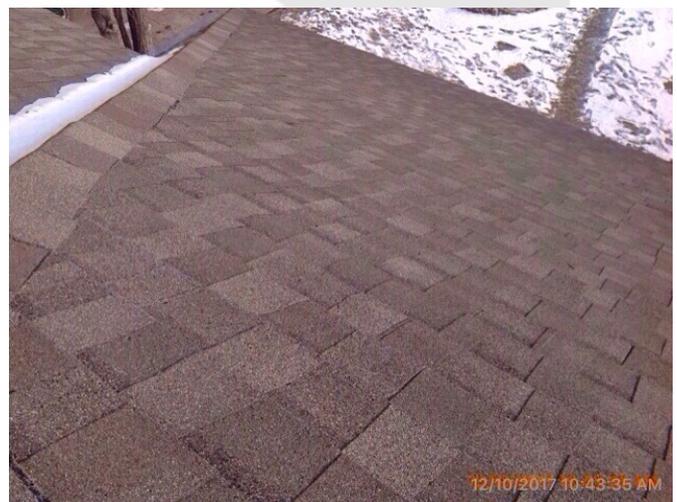
The moss on the ends of the underlying wood shingles tends to retain moisture and accelerate deterioration

over a long period of time. Cleaning and treating the lower edge of the roof will minimize damage to the sheathing and rafter tails.

This roof is near the end of its expected service life. Although it is presently watertight, the need for replacement should be expected within the next few years.

For further evaluation of roofing conditions, cost estimates and/or corrective repair, we recommend that a professional roofing contractor be retained.

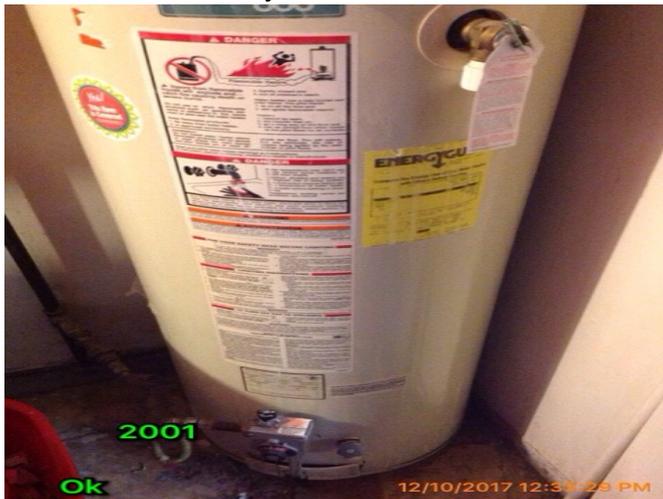
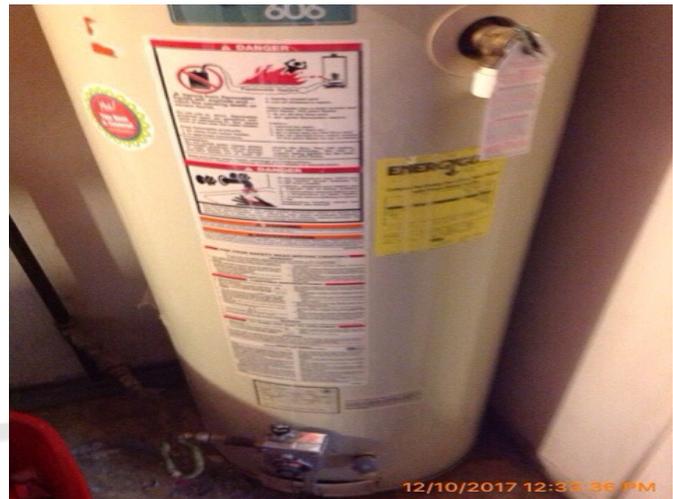
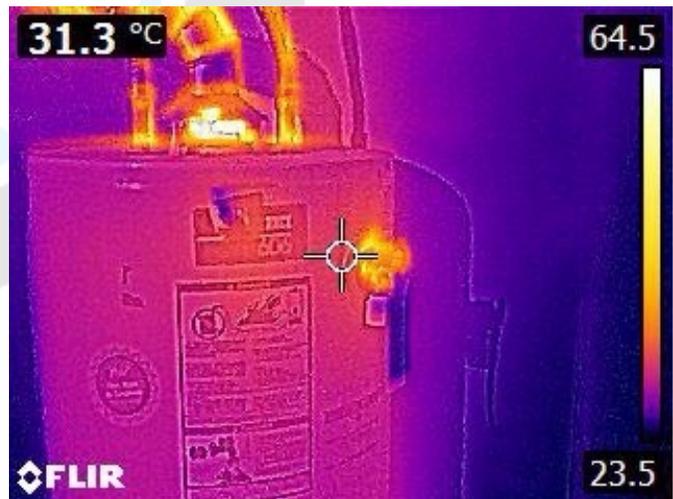
BASIC INFORMATION

Location: In the utility room

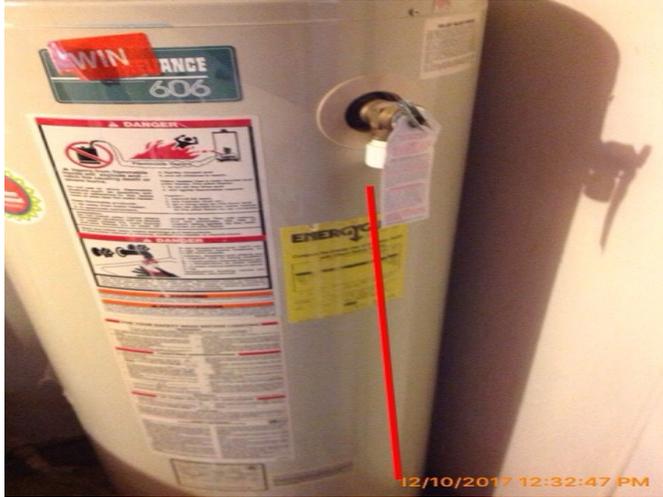
T/P RELEASE VALVE

The water heater is not equipped with a temperature and pressure relief valve. This is an important safety device. We recommend a relief valve be installed as soon as possible.

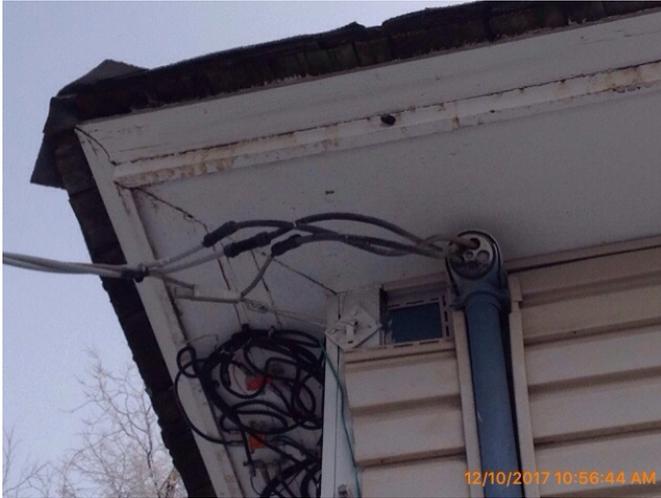
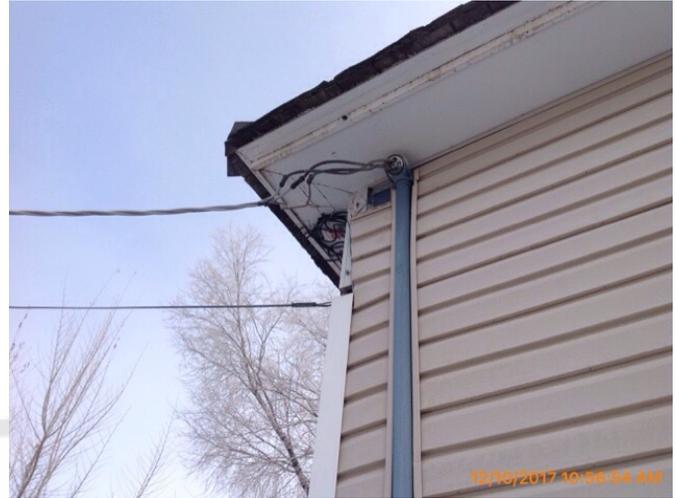
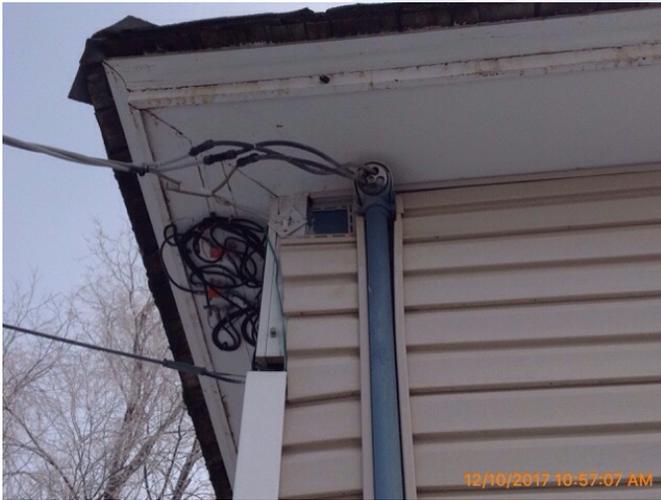
SERVICE DROP

The service drop appears to be properly installed and in good condition.

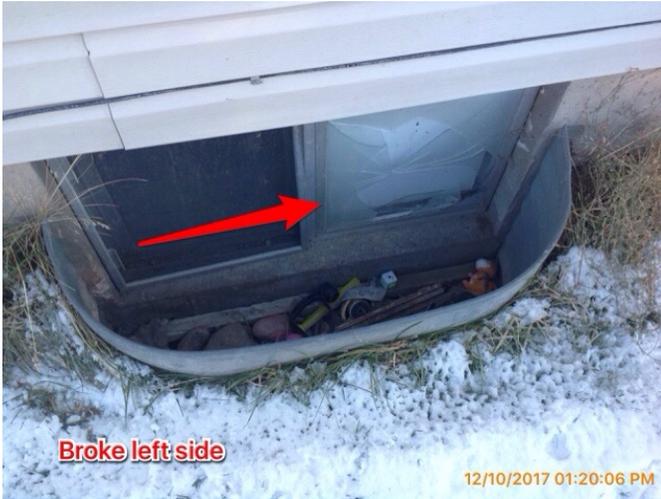
The windows appear to be properly installed and generally in serviceable condition. Some or all of the windows appear to be non-original. Review permits.

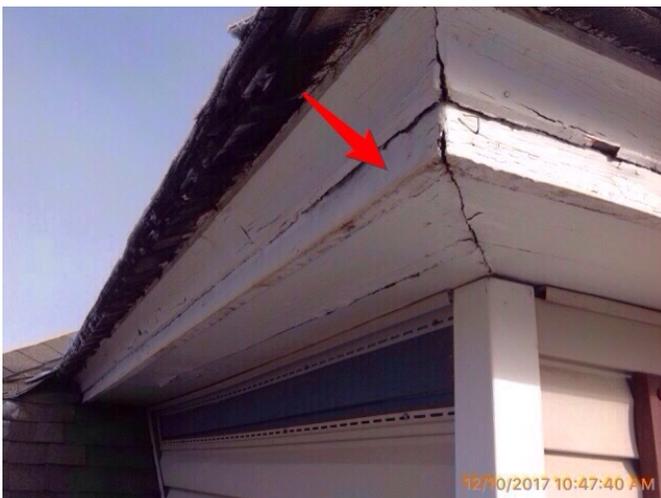
Sections of the eaves at the front are damaged. We recommend repair or replacement.

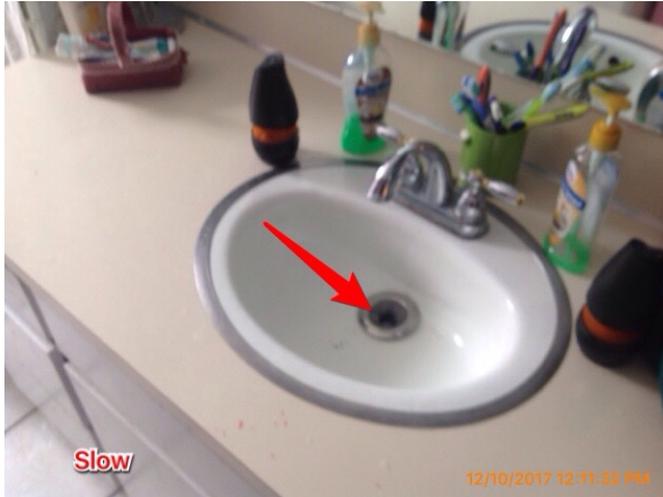
The drain is slow. We recommend the trap be cleaned of hair, sludge, etc. and if this does not correct the problem, we recommend the line be 'snaked' by a professional sewer cleaning service.

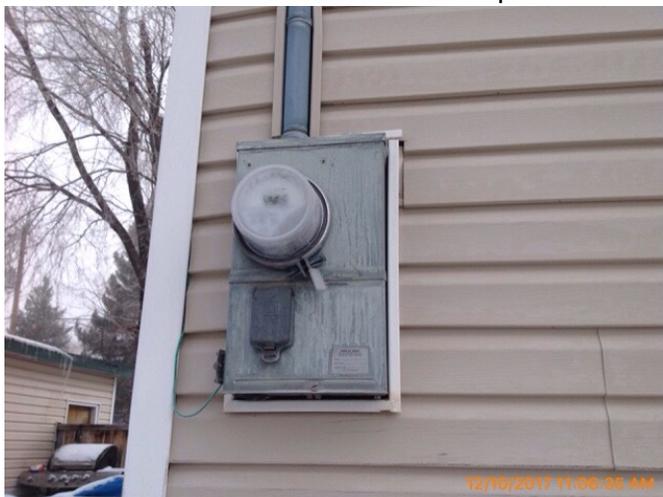
The meter and main electrical service panel are outside on the left side of the building.
